# Why Indeed Did the WTC Buildings Completely Collapse?

By Dr. Steven E. Jones

## ABSTRACT

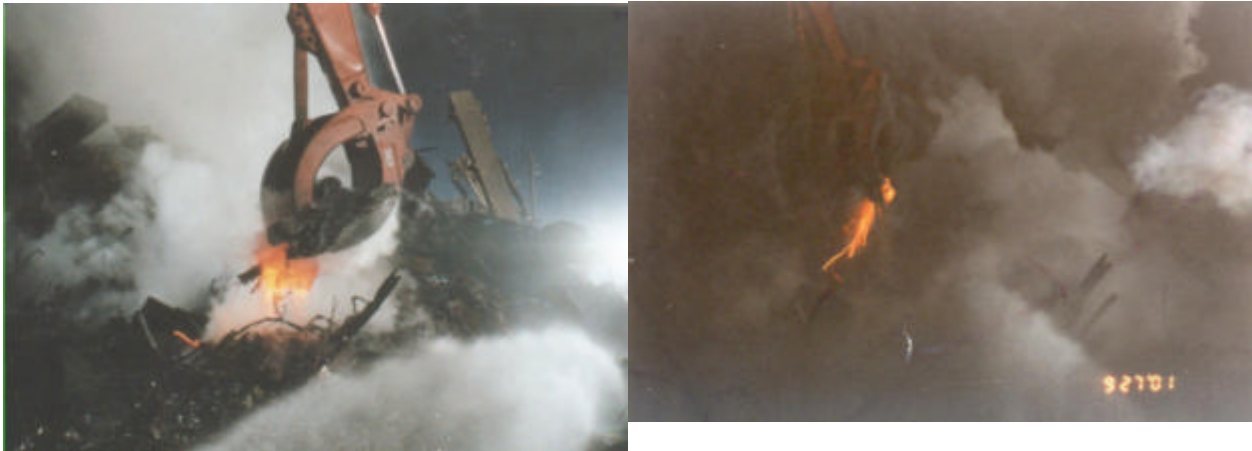
We start with the fact that large quantities of molten metal were observed in basement areas under rubble piles of all three buildings: the Twin Towers and WTC7. A video clip provides eye-witness evidence regarding this metal at ground zero: [http://plaguepuppy.net/public\\_html/video%20archive/red\\_hot\\_ground\\_zero\\_low\\_quality.wmv](http://plaguepuppy.net/public_html/video%20archive/red_hot_ground_zero_low_quality.wmv). The photographs below by Frank Silecchia show chunks of the hot metal being removed from the North Tower rubble on September 27, 2001 (according to photographer's aid). Notice the color of the lower portion of the extracted metal -- this tells us much about the temperature of the metal and provides important clues regarding its composition, as we shall see.

Even without a direct elemental analysis, we can rule out some metals based on available data. The photograph in the introduction shows a chunk of hot metal being extracted at ground zero. The hottest portion of the chunk is the lower portion, which was deepest down in the slag, and the metal is seen to be yellow-hot, certainly above cherry-red hot. The following table (see <http://www.processassociates.com/process/heat/metcolor.htm> ) provides data regarding the melting temperatures of lead, aluminum, structural steel and iron, along with approximate metal temperatures by color. Note that the approximate temperature of a hot metal is given by its color, quite independent of the composition of the metal. (A notable exception is falling liquid aluminum, which due to low emissivity and high reflectivity appears silvery-gray in daylight conditions, after falling through air 1-2 meters, regardless of the temperature at which the poured-out aluminum left the vessel. Aluminum does incandesce (glow) like other metals, but faintly, so that with the conditions described in the previous sentence (which prevailed at the WTC on 9/11), falling liquid aluminum will appear silvery-gray. Rapid oxidation of the hot flowing aluminum will contribute to the observed appearance. [Experiments: Jones, 2006])

We see from the photograph above that solid metal from the WTC rubble existed at salmon-to-yellow-hot temperature (approx. 1550 - 1900 °F, 845 - 1040 °C.) The temperature is well above the melting temperatures of lead, zinc and aluminum, and these metals can evidently be ruled out since they would be runny liquids at much lower (cherry-red or below) temperatures. However, the observed hot specimen could be structural steel (from the building) or iron (from a thermite reaction) or a combination of the two. Additional photographs of the hot metal could provide further information and advance the research.

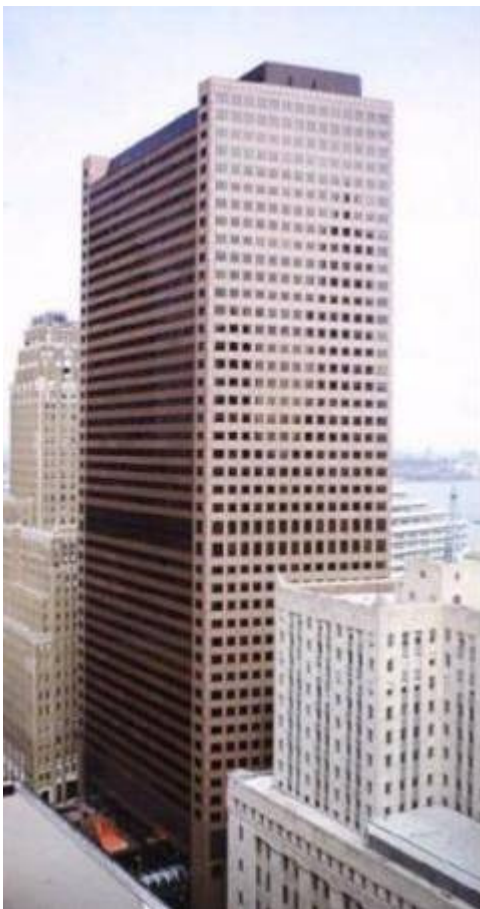
**Next, as a basis for discussion, I invite you to consider the collapse of the 47-story WTC 7, which was never hit by a jet. Here is the building prior to and on September 11, 2001:**

**WTC 7: 47 - Story, steel-frame building..**

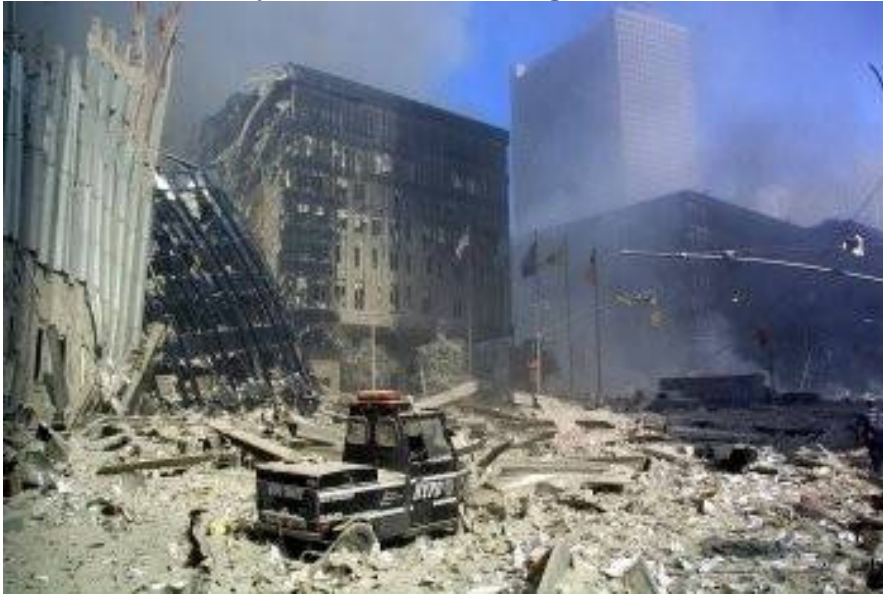
**WTC 7 on 9-11-01. WTC 7 is the tall sky-scra-per in the background, right. Seen from WTC plaza / Church Street area.**

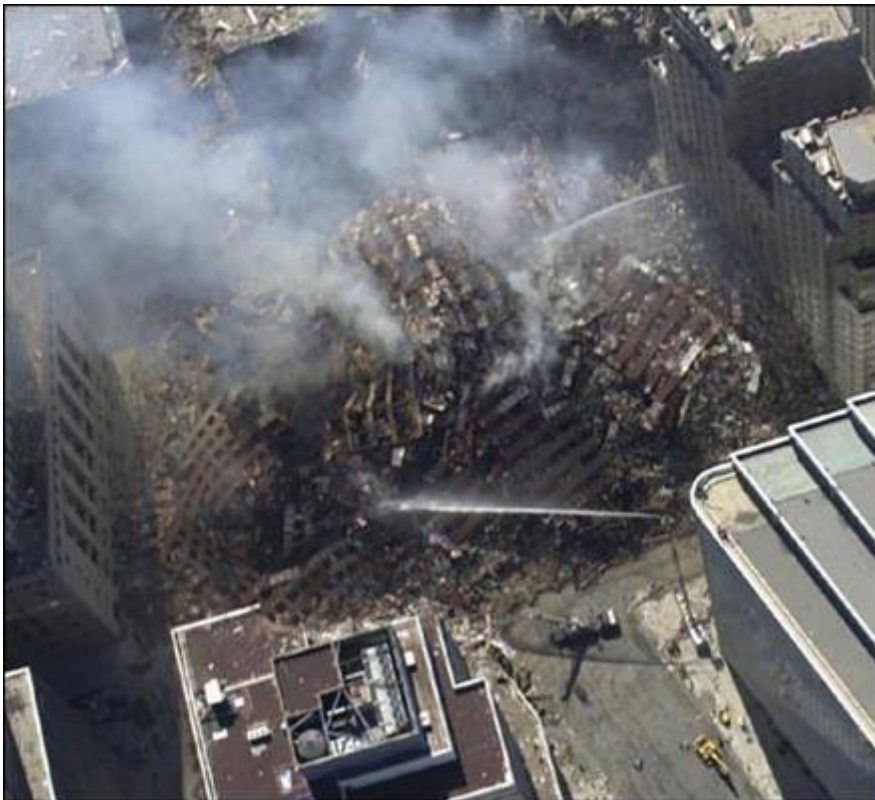
**WTC 7 collapsed completely, primarily onto its own footprint.**

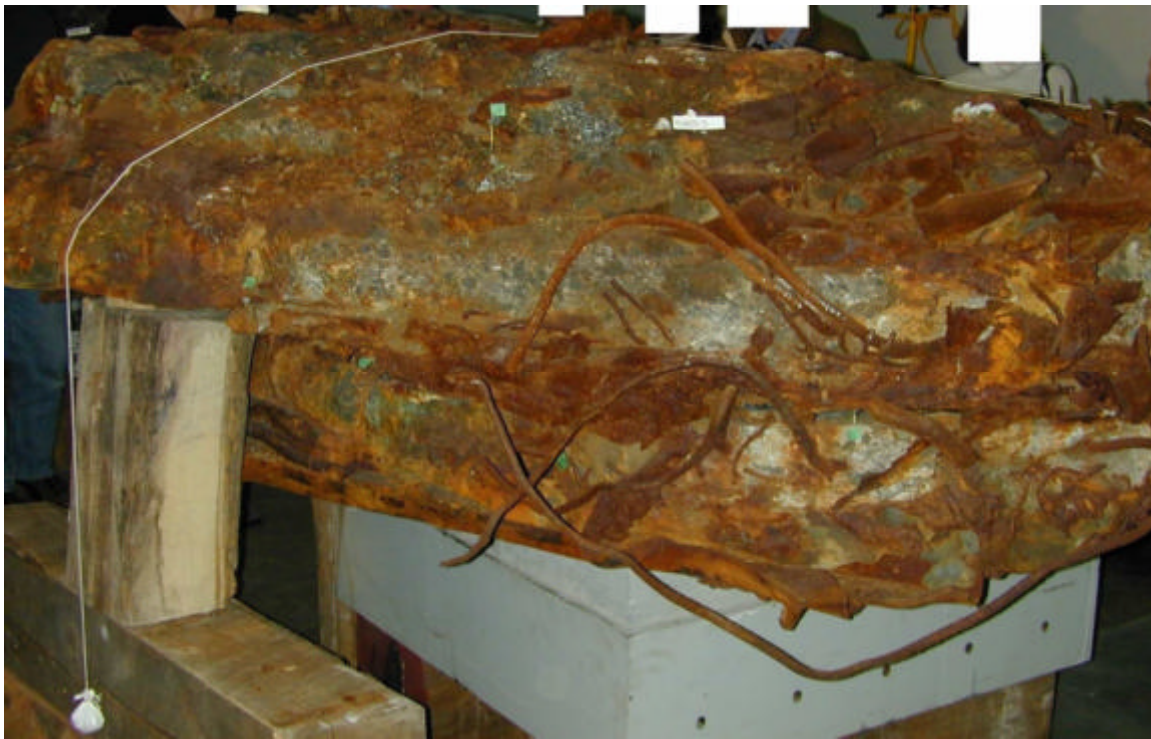
The following photograph has become available, evidently showing the now-solidified metal with entrained material, stored (as of November 2005) in a warehouse in New York:

The abundance of iron (as opposed to aluminum) in this material is indicated by the reddish rust observed. When a sample is obtained, a range of characterization techniques will quickly give us information we seek. X-ray energy dispersive spectrometry (XEDS) will yield the elemental composition, and electron energy-loss spectroscopy will tell us the elements found in very small amounts that were undetectable with XEDS. Electron-backscattered diffraction in the scanning electron microscope will give us phase information; the formation of certain precipitates can tell us a minimum temperature the melt must have reached. We will endeavor to obtain and publish these data, whatever they reveal.

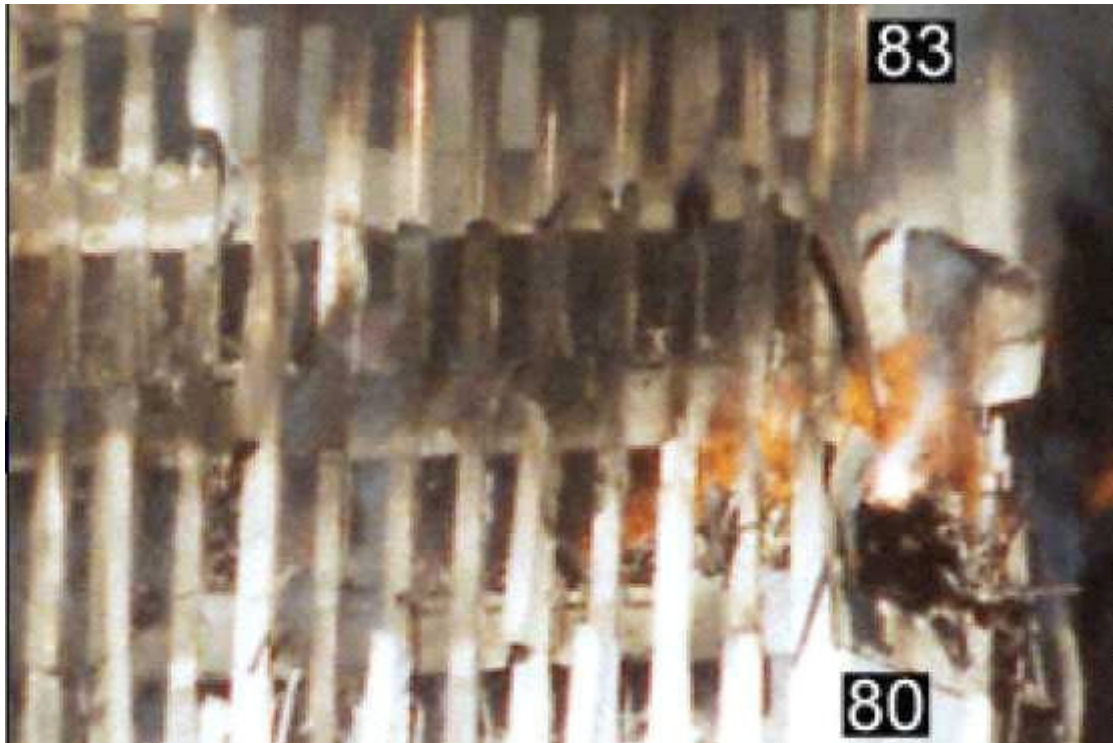
An intriguing photograph found as Figure 9-44 in the NIST report provides evidence for a highly exothermic reaction at the corner of the South Tower just minutes before its collapse. Furthermore, failure occurs at this very corner of the Tower as seen in this video footage: <http://video.google.com/videoplay?docid=-8564772103237441151&q=cameraplanet+9%2F11> .

“An **unusual flame** is visible within this fire. In the upper photograph {Fig 9-44} a **very bright flame, as opposed to the typical yellow or orange surrounding flames, which is generating a plume of white smoke, stands out.**” Source: NCSTAR 1-5A Chapter 9 Appendix C NIST Fig. 9-44. p. 344

“NIST reported (NCSTAR 1-5A) that just before 9:52 a.m., a **bright spot appeared** at the top of a window on the 80th floor of WTC 2, four windows removed from the east edge on the north face, **followed by the flow of a glowing liquid.** This flow lasted approximately four seconds before subsiding. **Many such liquid flows were observed from near this location in the seven minutes leading up to the collapse of this tower.**” Source:

Thus it is established that the "glowing liquid" flow is associated spatially and temporally with the "bright spot" observed on the corner of the 80th floor of WTC 2. The photograph below shows, for comparison, a thermite reaction with a white aluminum-oxide dust plume extending from very bright reaction region. (Experiment by the author and colleagues in which thermite-plus-sulfur cut through a steel cup in a fraction of a second. Any thermite reaction is a dangerous reaction and should only be performed by a trained professional capable of assessing the hazards and risks.) The similarities between the known thermite reaction and the hitherto unknown reaction at the WTC Tower are plain to see. These discoveries strongly motivate an immediate in-depth investigation of the use of thermite-type reactions in the destruction of the World Trade Center on 9/11/2001.

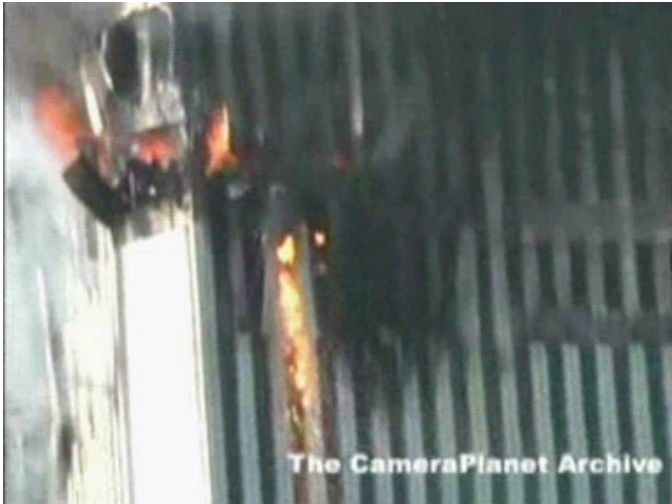
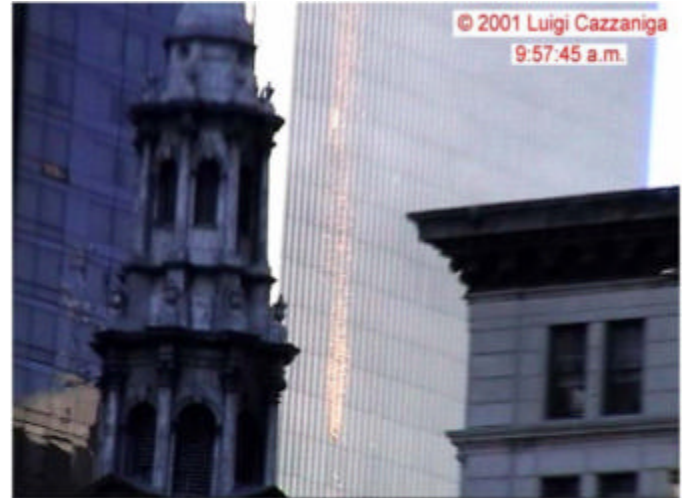
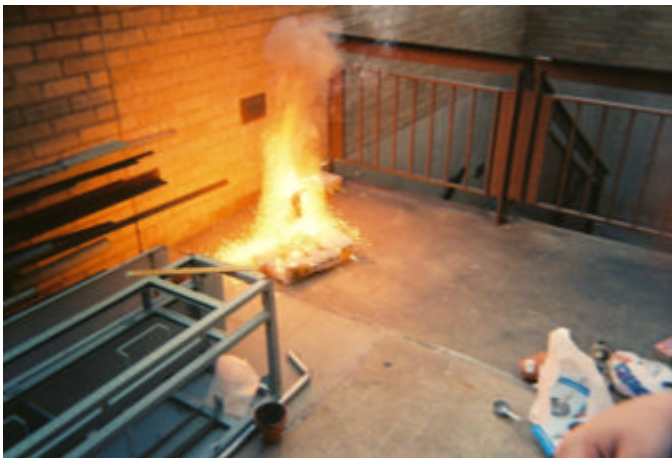
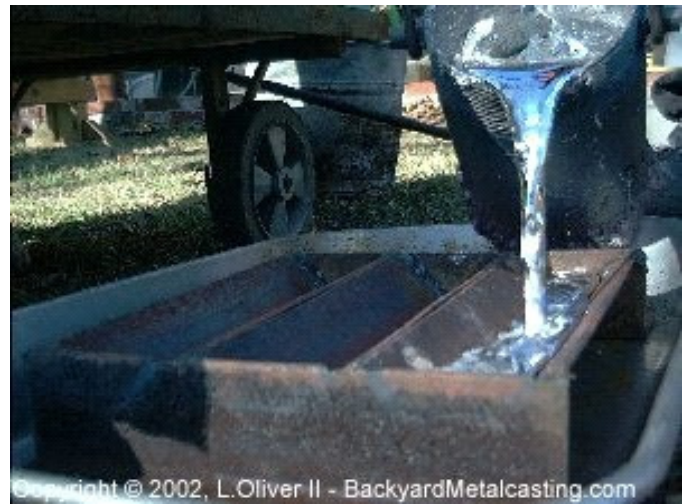
Is the falling molten metal from WTC Tower 2 (Top photos) more likely molten iron from a thermite reaction (lower left) OR pouring molten aluminum (lower right)?

Who can deny that liquid, molten metal existed at the WTC disaster? The yellow color implies a molten-metal temperature of approximately 1000 °C, evidently above that which the dark-smoke hydrocarbon fires in the Towers could produce. If aluminum (e.g., from the plane) had melted, it would melt and flow away from the heat source at its melting point of about 650 °C and thus would not reach the yellow color observed for this molten metal. Thus, molten aluminum is already ruled out with high probability. But molten iron with the characteristics seen in this video is in fact consistent with a thermite-reaction attacking the steel columns in the Tower, thus weakening the building just prior to its collapse, since thermite produces molten iron at yellow-to-white hot temperatures. (As some of the molten metal hits the side of the building in the video clip above, the white-hot interior is evidently exposed as the metal "splashes".) Also, the fact that the liquid metal retains an orange hue as it nears the ground (right photograph) further rules out aluminum, and suggests a mid-flight thermite reaction (typical of thermite).

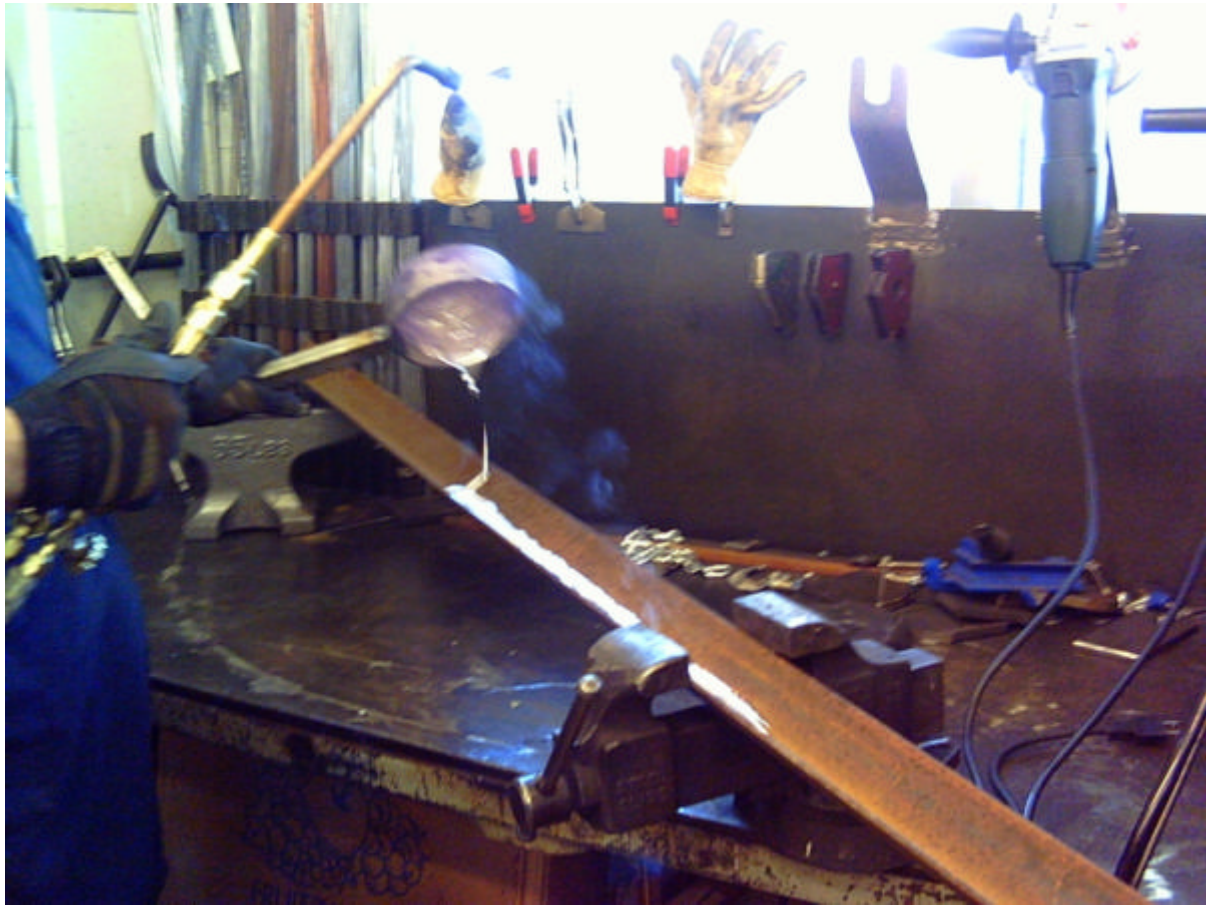
Molten aluminum poured onto rusted steel: silvery flow, and **no** violent reactions observed at all (contrary to predictions by some of a vigorous aluminum-rust “thermitic reaction”). Same result -- when the rusty steel piece was pre-heated with the torch.

We also noted that while a steel pan holding the aluminum glowed red and then yellow hot, when poured out the falling aluminum displayed a silvery-gray color, adding significantly to the evidence that the yellow-white molten metal flowing out from the South Tower shortly before its collapse was NOT molten aluminum. (Recall also that the yellow color of the molten metal (video clip above) implies a temperature of approximately 1100°C -- too high for the dark-smoke hydrocarbon fires burning in the building.) This is a point worth emphasizing: aluminum has low emissivity and high reflectivity, so that in daylight conditions after falling through air 1-2 meters, molten aluminum will appear silvery-gray, while molten iron (with its characteristic high emissivity) will appear yellow-white (at ~1100°C) as observed in the molten metal dripping from the South Tower just before its collapse (see: <http://www.supportthetruth.com/jones.php> ). We also recall that this molten metal, after falling approximately 150 meters (or yards) still retained a reddish orange color (photograph above). This is not the behavior of falling, molten aluminum.

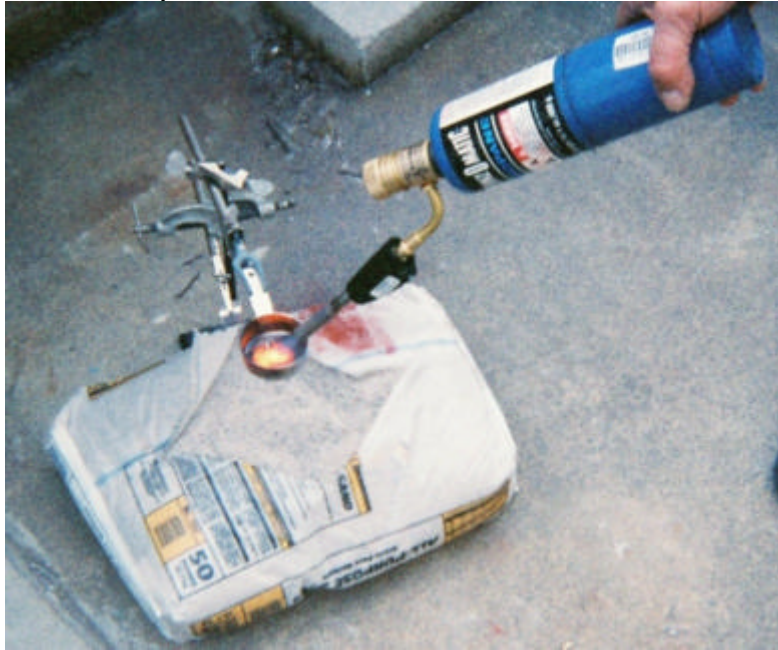
Thermite did not ignite when heated with a propane torch.

It is important to note that initiating the thermite reaction requires temperatures well above those achieved by burning jet fuel or office materials -- which is an advantage of using thermite charges over conventional monomolecular explosives such as TNT, RDX and PETN. Below is a photograph of an experiment performed by the author and colleagues at BYU in which a sample of thermite was heated to orange-hot temperature (about 1700 °F). We demonstrated that the thermite reaction would not ignite at this high temperature. Later, the

thermite reaction was triggered by burning a magnesium strip in contact with the thermite. An electrical superthermite "match" could have been used and remotely triggered via radio signal.

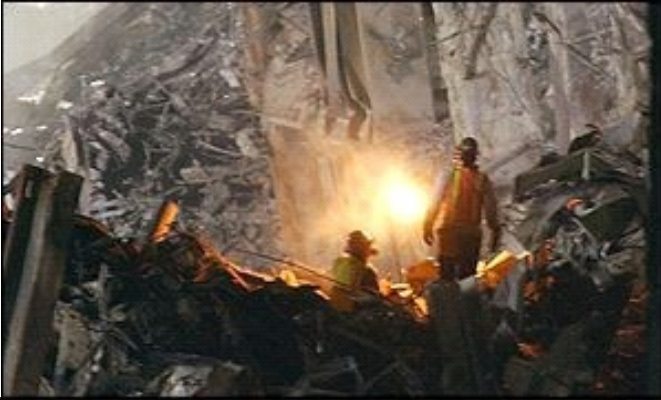
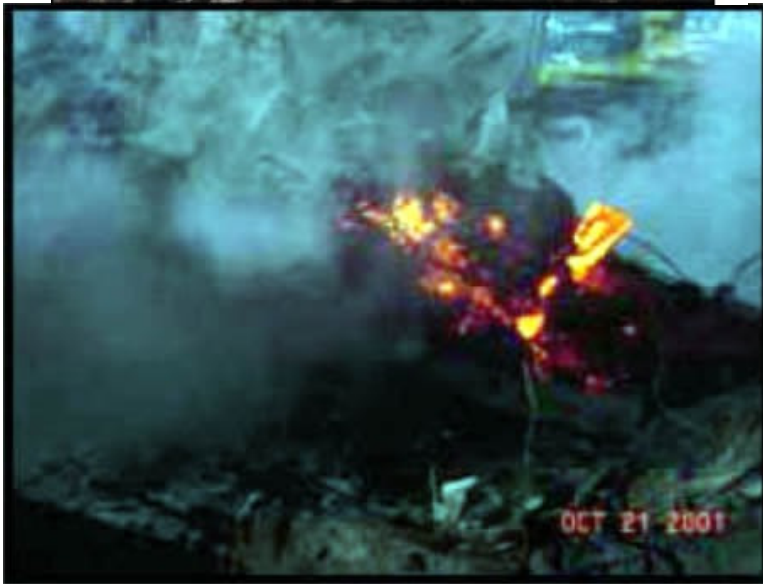
The top photo (<http://news.bbc.co.uk/2/hi/science/nature/1858491.stm>) may show the glow of hot metal in the rubble; the second photo clearly does so. It is labeled “Red Hot Debris” and is published in **LiRo News, Nov. 2001**, <http://www.liro.com/lironews.pdf> . Moreover, there is recorded eyewitness testimony of the molten metal pools under both Towers and WTC 7; see: <http://georgewashington.blogspot.com/2005/12/why-was-there-molten-metal-under.html> . . A video clip provides eye-witness evidence regarding this metal at ground zero: [http://plaguepuppy.net/public\\_html/video%20archive/red\\_hot\\_ground\\_zero\\_low\\_quality.wmv](http://plaguepuppy.net/public_html/video%20archive/red_hot_ground_zero_low_quality.wmv) .

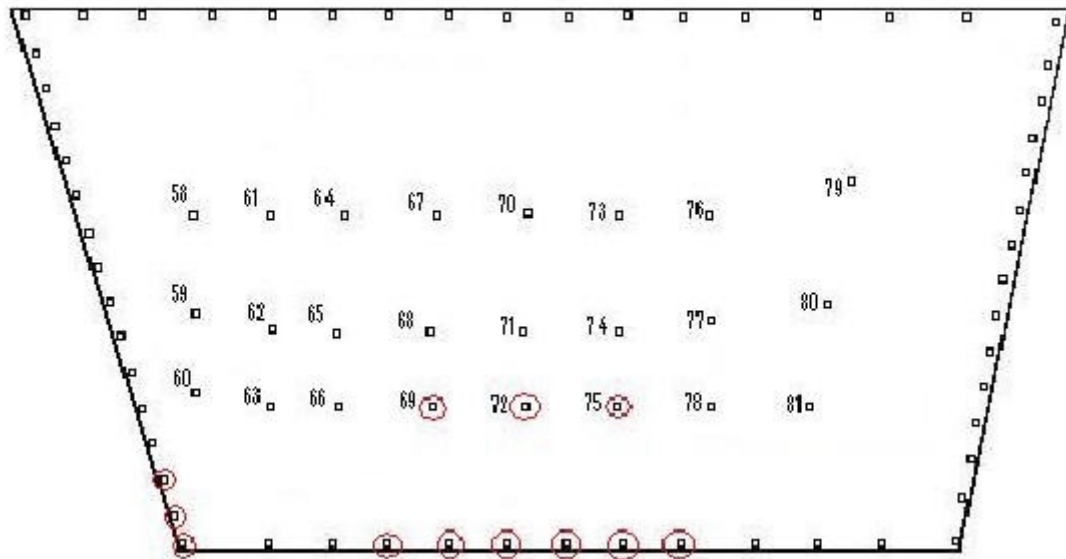
Diagram showing steel-column arrangement in WTC 7, view looking down on the roof. Circled columns were possibly damaged due to debris from WTC 1 collapse, some 350 feet away (NIST, 2005) so the damage was clearly non-symmetrical, and evidently, none of the core columns was severed by falling debris. WTC 7 was never hit by a plane.

As you observed (link above), WTC 7 collapsed rapidly and nearly-straight-down symmetrically -- even though fires were randomly scattered in the building. WTC 7 fell about seven hours after the Towers collapsed, even though no major persistent fires were visible (considerable dark smoke was seen). There were twenty-four huge steel support columns inside WTC 7 as well as huge trusses, arranged non-symmetrically, along with some fifty-seven perimeter columns, as indicated in the diagram below (FEMA, 2002, chapter 5; NIST, 2005).

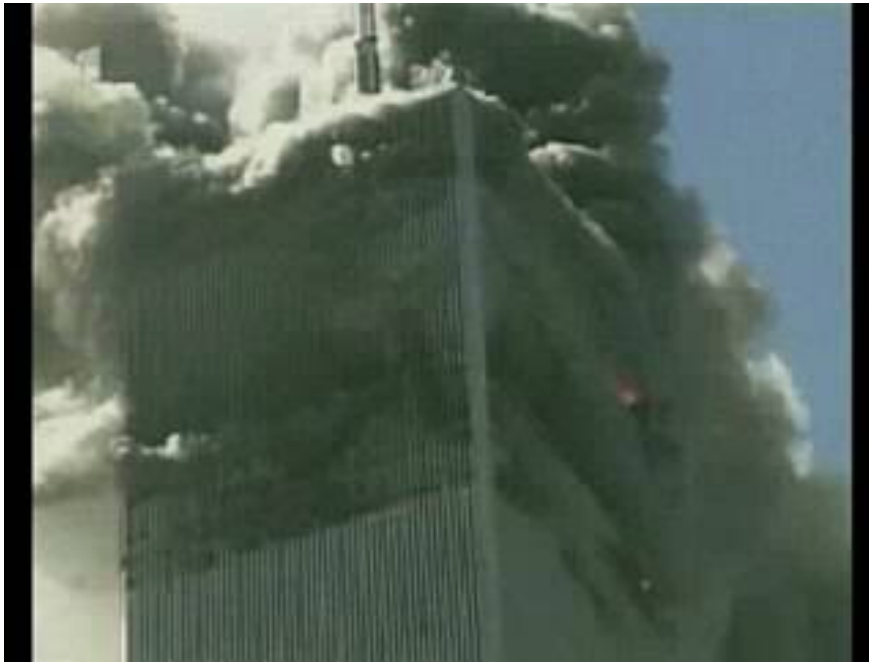
North Tower showing antenna (top) at beginning of collapse.

Review of videotape recordings of the collapse taken from various angles indicates that the transmission tower on top of the structure began to move downward and laterally slightly before movement was evident at the exterior wall. This suggests that **collapse began with one or more failures in the central core area of the building.** (FEMA, 2002, chapter 2; emphasis added.)

Yes, we can see for ourselves that the antenna drops first from videos of the North Tower collapse. (See [http://911research.wtc7.net/wtc/evidence/videos/wtc1\\_close\\_frames.html](http://911research.wtc7.net/wtc/evidence/videos/wtc1_close_frames.html); also <http://home.comcast.net/~skydrifter/collapse.htm>.) A NY Times article also notes this behavior:

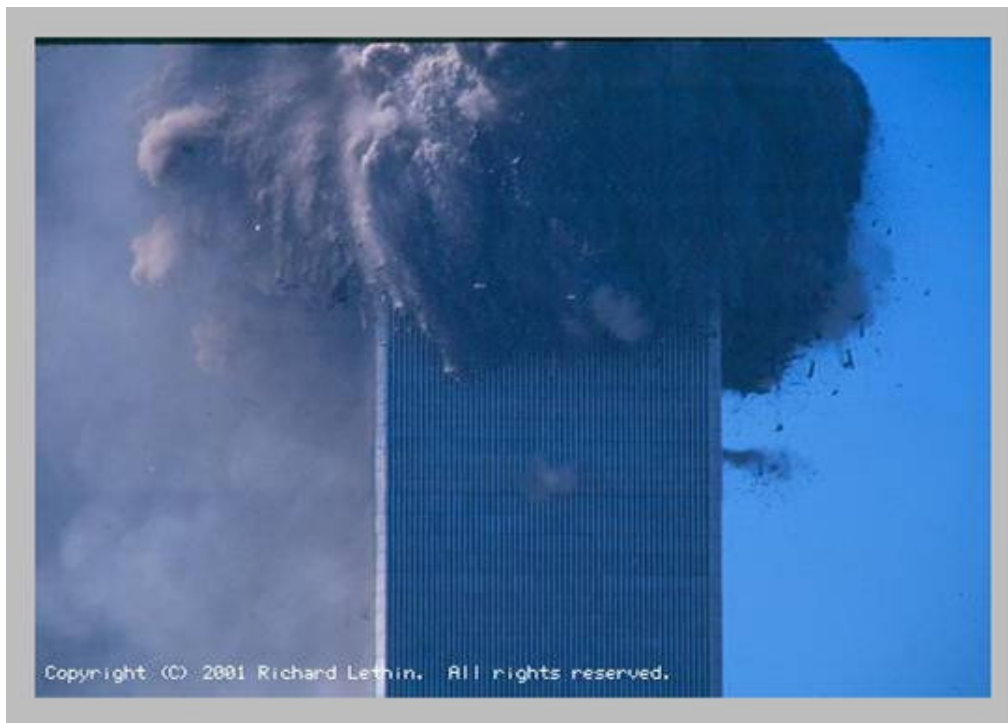
North Tower during top-down collapse.  
Notice mysterious horizontal plumes far below pulverization region.

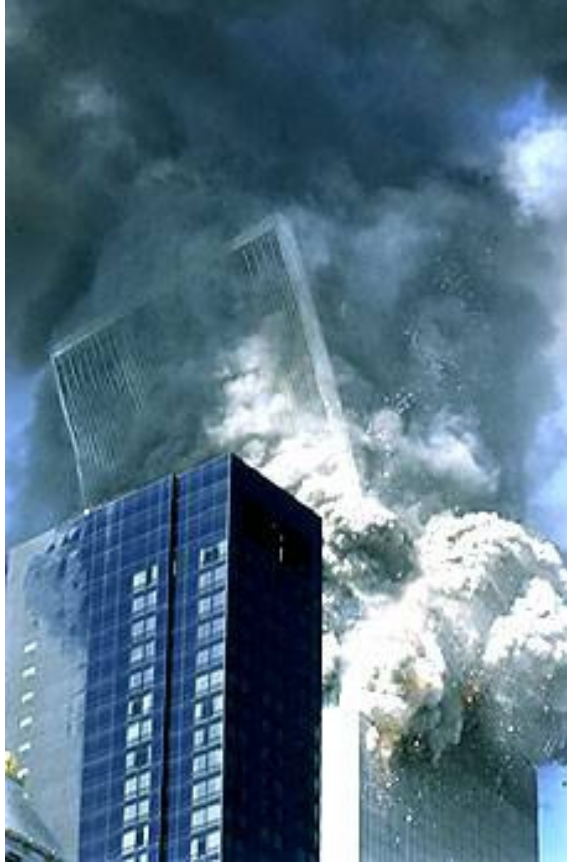
Top ~ 30 floors of South Tower topple over.  
What happens to the block and its angular momentum?

We observe that approximately 30 upper floors begin to rotate as a block, to the south and east. They begin to topple over, not fall straight down. The torque due to gravity on this block is enormous, as is its angular momentum. But then – and this I’m still puzzling over – this block turned mostly to powder *in mid-air*! How can we understand this strange behavior, without explosives? Remarkable, amazing – and demanding scrutiny since the US government-funded reports failed to analyze this phenomenon. But, of course, the Final NIST 9-11 report “**does not actually include the structural behavior of the tower after the conditions for collapse initiation were reached.**” (NIST, 2005, p. 80, fn. 12; emphasis added.)

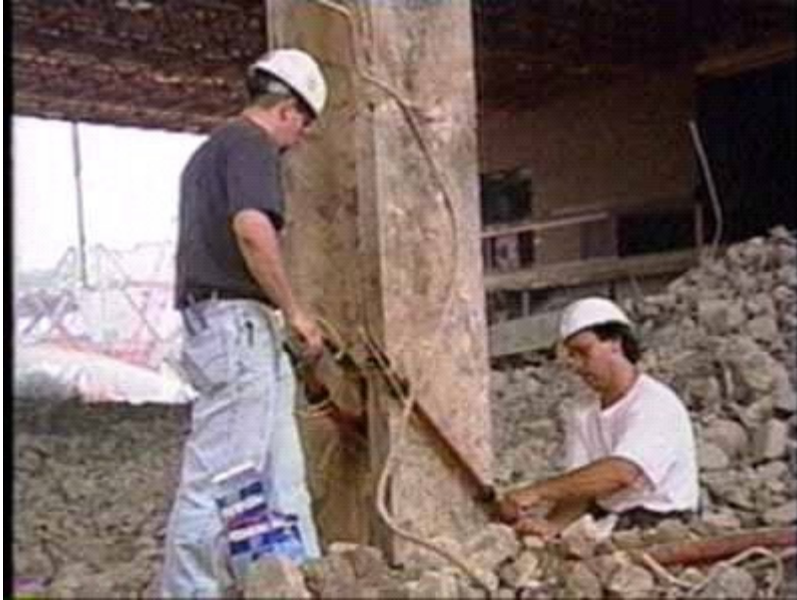
Above: two men install a conventional cutter charge to steel column, preparing for a controlled demolition of the building. Notice the narrow width/size of the explosive cutter charge. From History Channel: “Wrecking ball – Modern marvels” and thanks to Robert Moore and <http://piratenews.org/911con.html> . For comparison, observe some of the angle-cut columns seen at Ground Zero after 9/11/2001, below. (Notice especially the uneven cut at the back of the column and the clinging previously-molten metal on both the outside AND the inside of the column, left photo, suggesting this was NOT cut using an oxy-acetylene torch, but rather that a highly exothermic chemical reaction was involved in cutting through this steel column.)

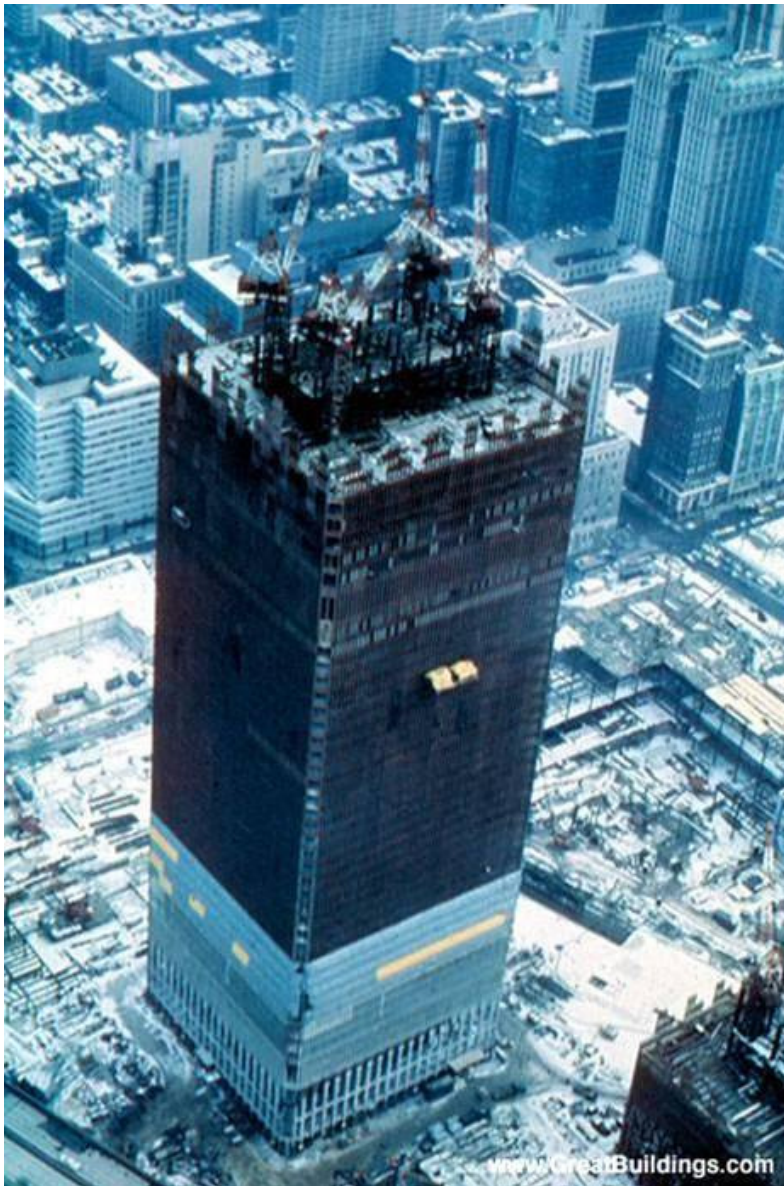
The WTC towers were solidly constructed with 47 steel core columns and 240 perimeter steel columns. 287 steel-columns total.

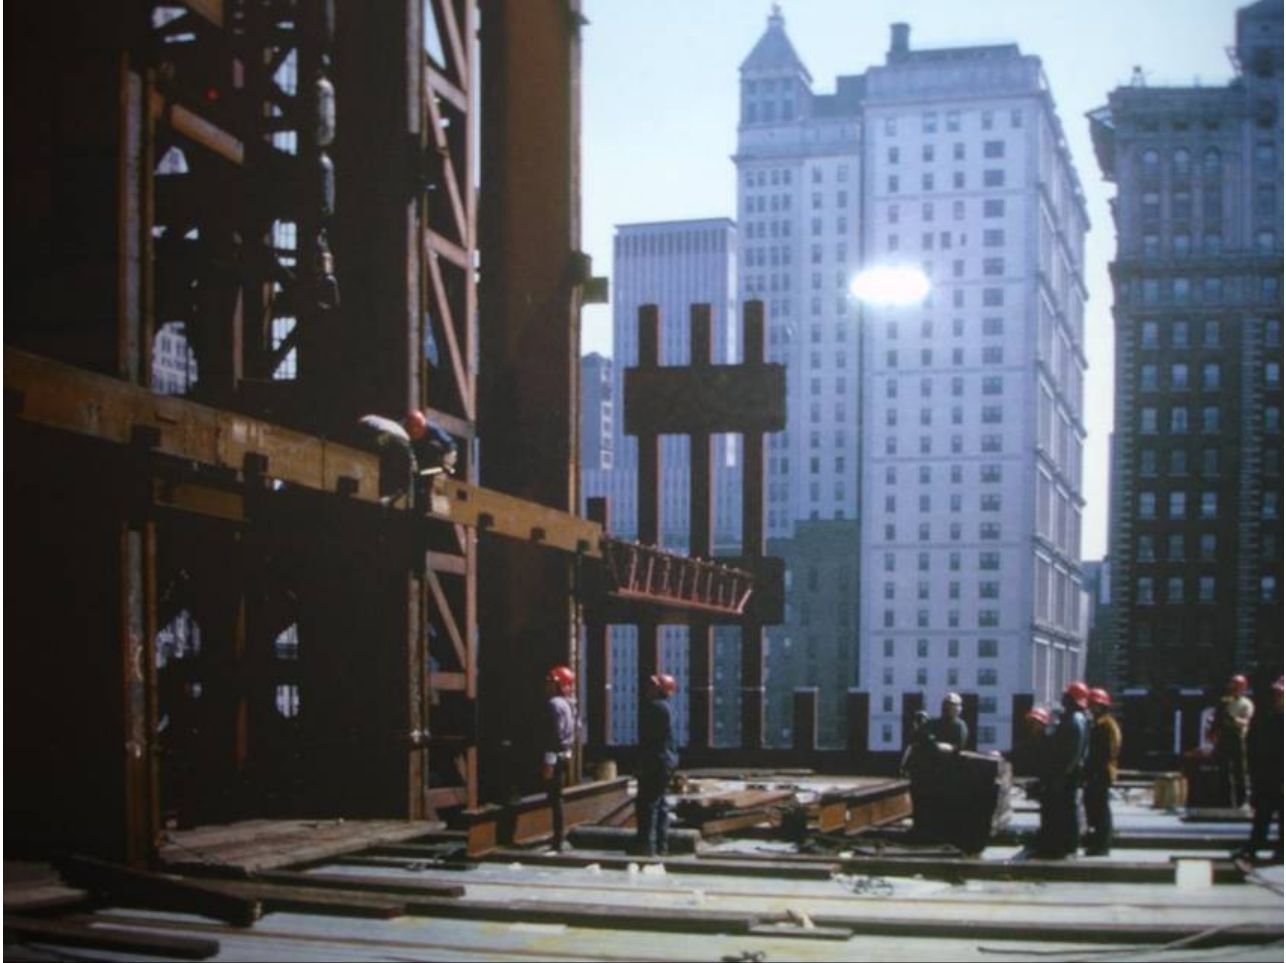
Steel-frame: Huge core (left) is an enormous heat sink. Notice workers standing on floor pan which is firmly attached to the interconnected core columns. Clearly, **the Towers were not “hollow tubes.”**
